A Flowchart For Evaluating Dairy Cow Freestalls

Ken Nordlund, DVM, Diplomate, ABVP-Dairy
Nigel B. Cook, BVSc, Cert CHP, DBR, MRCVS
School of Veterinary Medicine, UW-Madison

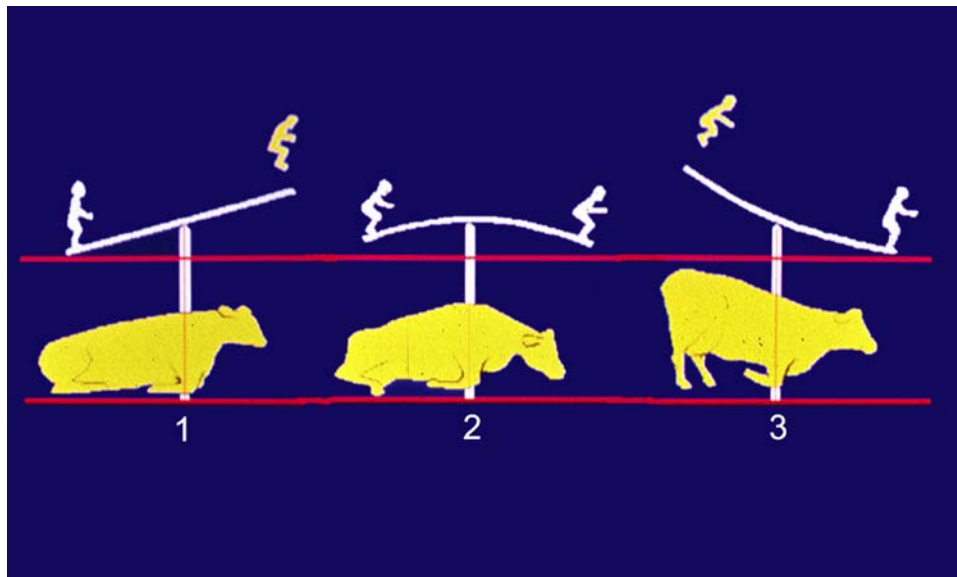
Figure 2: Flowchart for Evaluating Freestalls

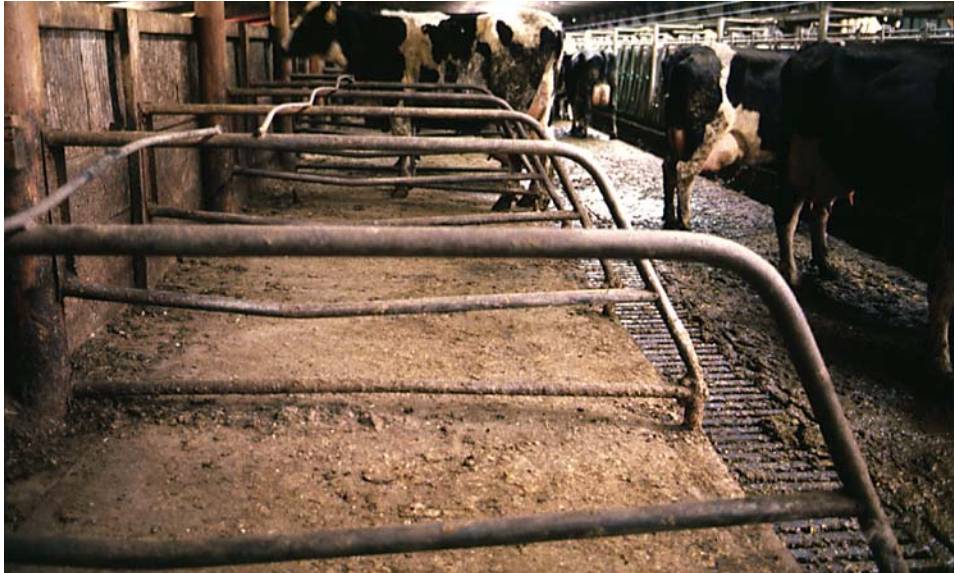
Figure 4: Failure to replace sand has caused the rear curb to protrude and shorten the effective resting body space, resulting in the heifers refusing to use the stalls.

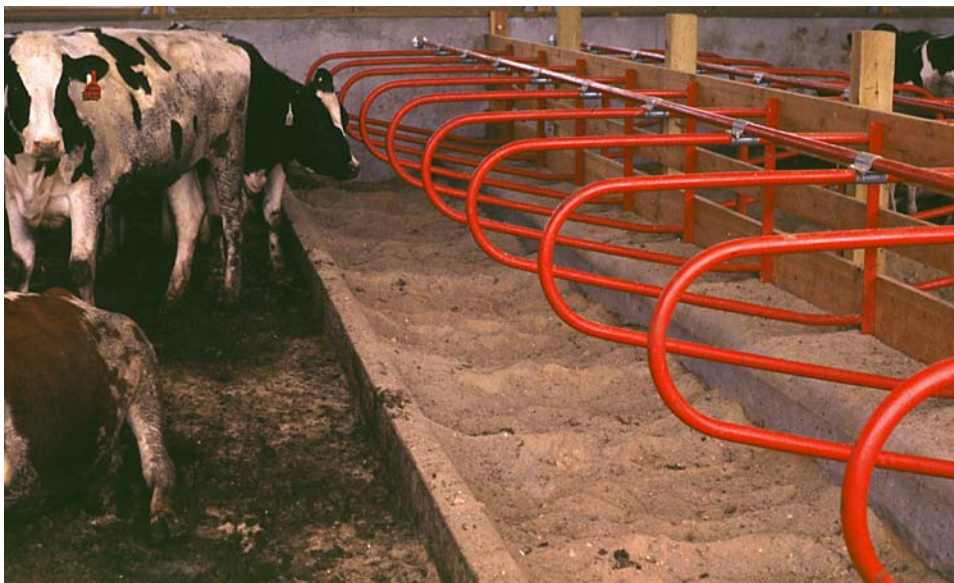
Figure 5: Failure to maintain sand has resulted in a fully exposed 2" x 12" brisket board, resulting in impediments to the "lunge and bob motion" and to the forward extension of the front legs.
